## The Primitive Hall Restoration Chronology

### **1925, The Clarence W. Brazer Primitive Hall Design Portfolio**

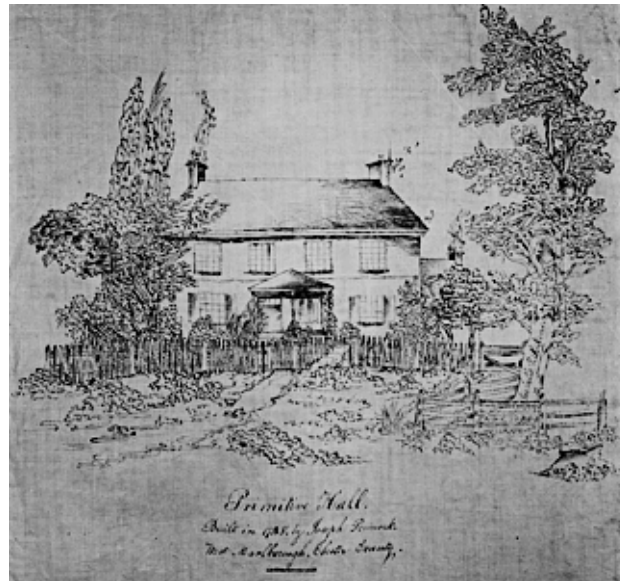
1843 Sketch of Primitive Hall by Isabella Pennock Lukens. The earliest image of the Hall

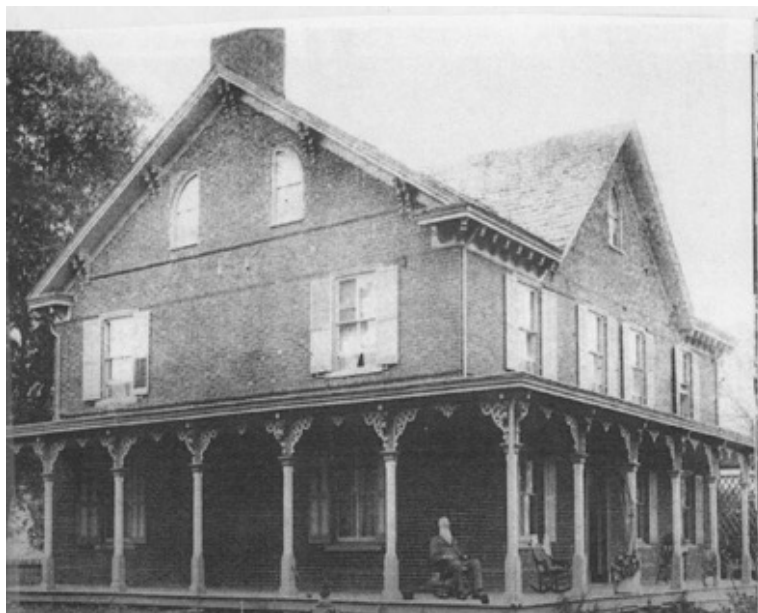
1870 The Victorian treatment of Primitive Hall, The features included large glass panes 2  
over 2 lite windows, prominent front and side gables with pointed arch windows,

brackets, and wrap around porch. Windows were added and opening were changed removing the earlier structures. The designer and craftsmen of this phase are not known.

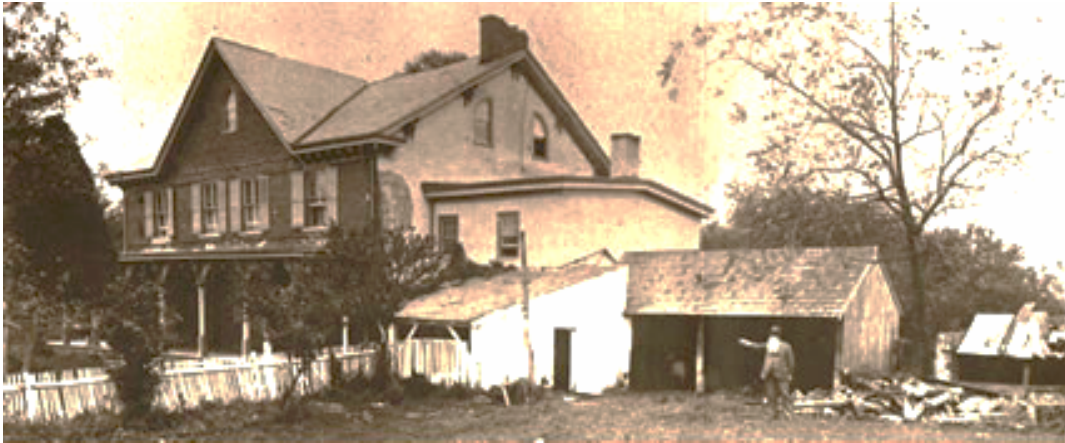
1920 Primitive Hall as acquired by Stuart Huston. The Hall has fallen into disrepair. The facade applied to the earlier core structure and the auxiliary buildings will be removed. Other than photographs there is limited documentation of the Victorian features added and removed.

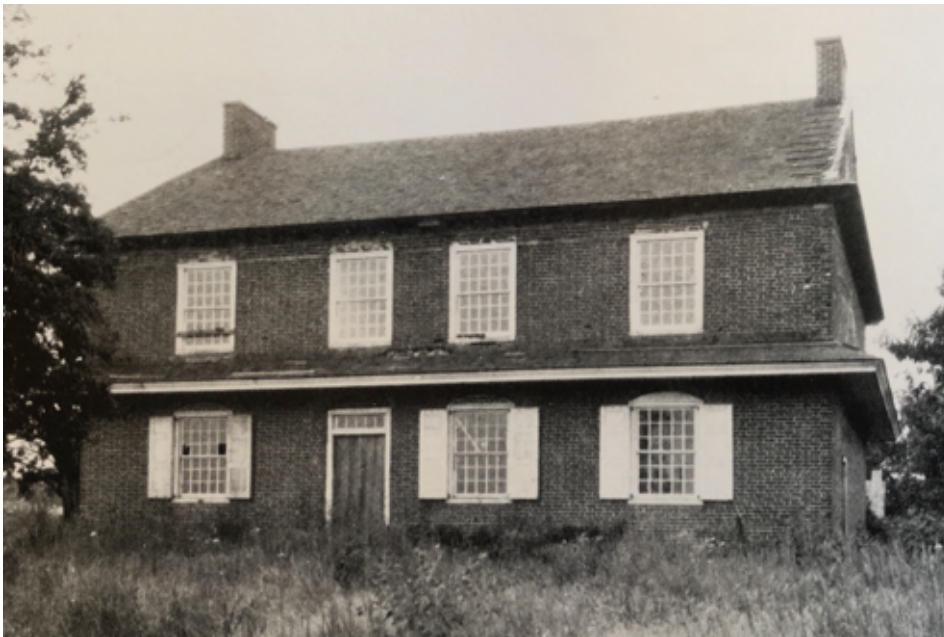
1930 The 18<sup>th</sup> Century Primitive Hall<sup>1</sup> is beginning to emerge. Key restoration decisions

are displayed on the Clarence W. Brazer's architectural drawings dated 1925. The influences of Brazer's designs are pervasive in the restoration. Over the next 60 years the restoration work will follow his plans. He proposed design changes to restore the Hall to a 1738 period. Windows were redesigned, pent eve added based on brick scars, and Cove eve

built based on brick scars. Two external doorways, two internal doorways, and six window openings were infilled. Choice<sup>2</sup> of external opening to be maintained was made by the presence of ghosts of segmented arches. Openings without these scars were not considered original to the 1738 building and were closed.

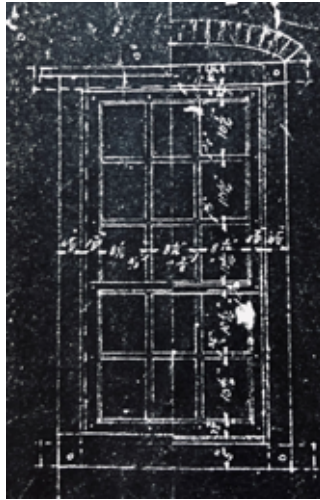
Gable end elevation 9x6 window .  
Designed and installed in 1925-1930

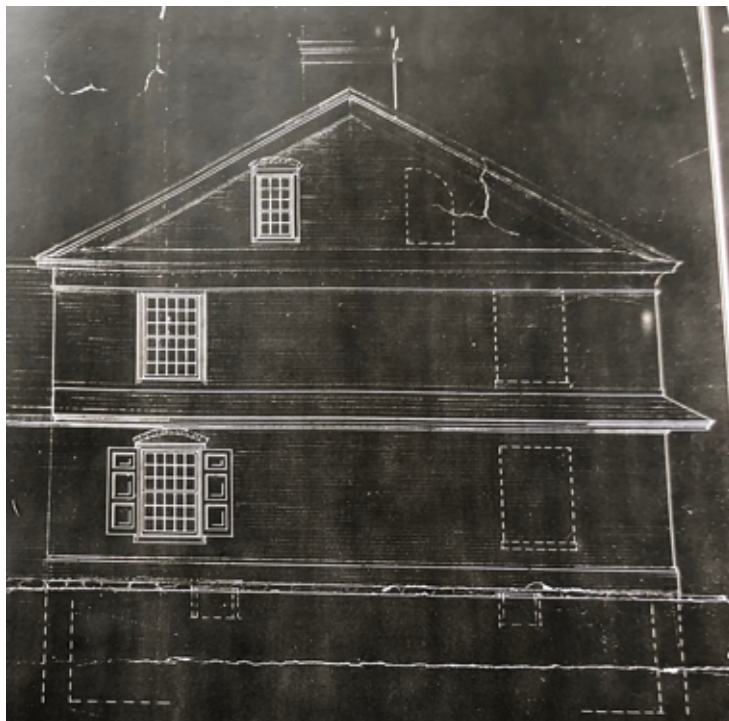
West Gable Elevation. The dashed figures indicate infills.  
The pent eve and cove molding were restored fitting to the  
scars on the brick face.

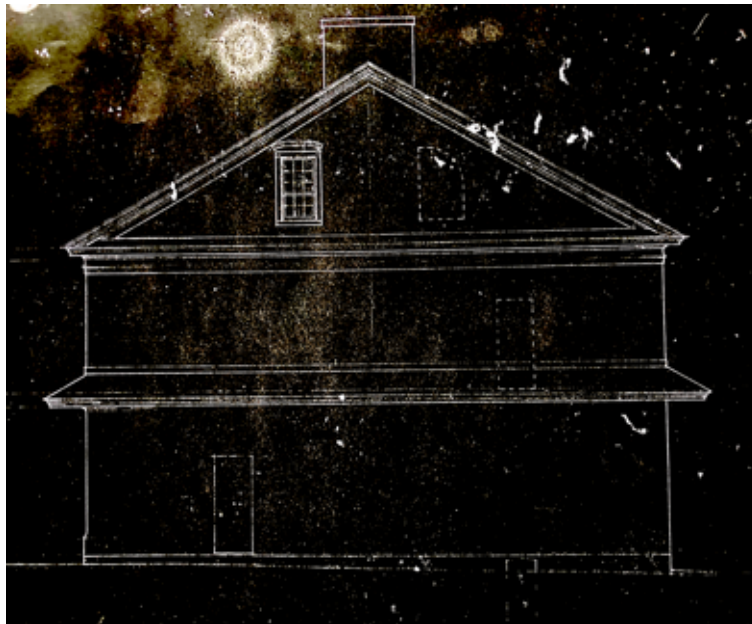
East Gable Elevation. The dashed figures indicate infills.

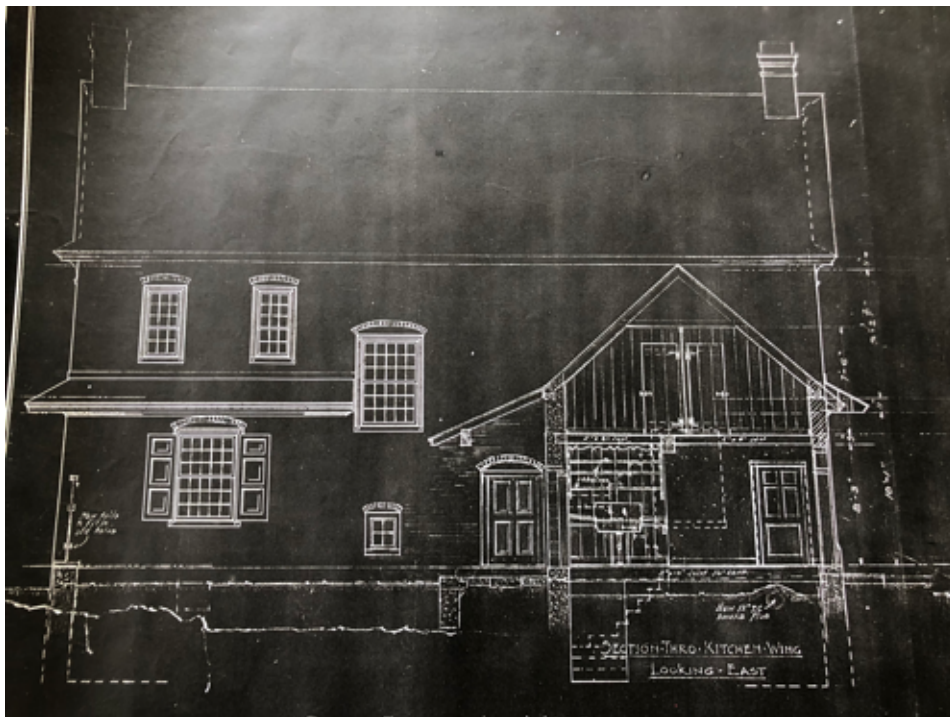
North Gable Elevation. Included is a proposed attached kitchen. This kitchen design was not implemented.

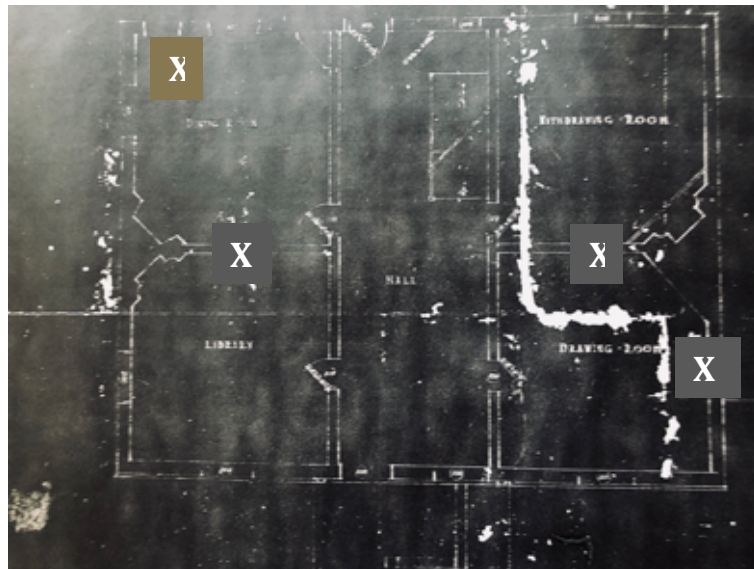
Interior first floor plan. Door closures X designation. The door configuration and two kitchens supported the 19<sup>th</sup> century use of Primitive Hall as a two-family residence with east and west quarters.

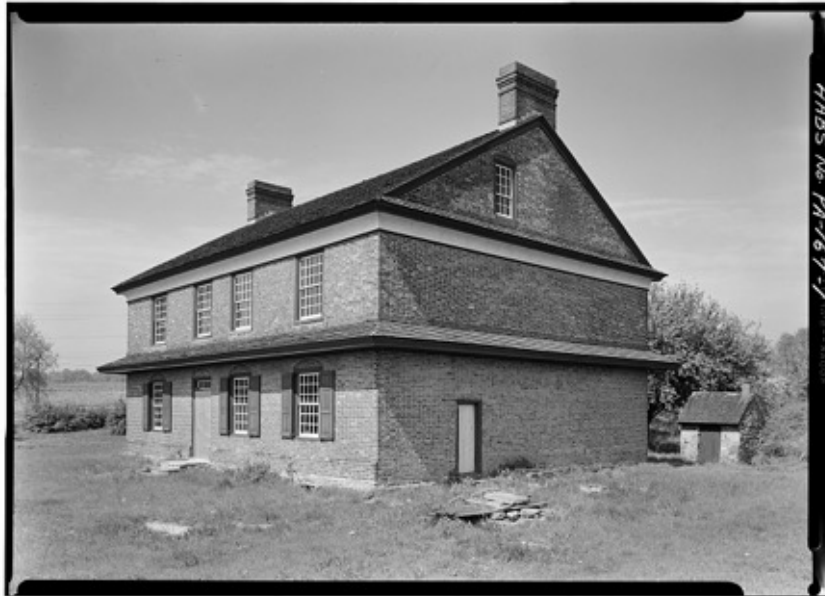
1959 HABS Photograph, South Elevation External restoration complete except for east gable door and north elevation door removals.

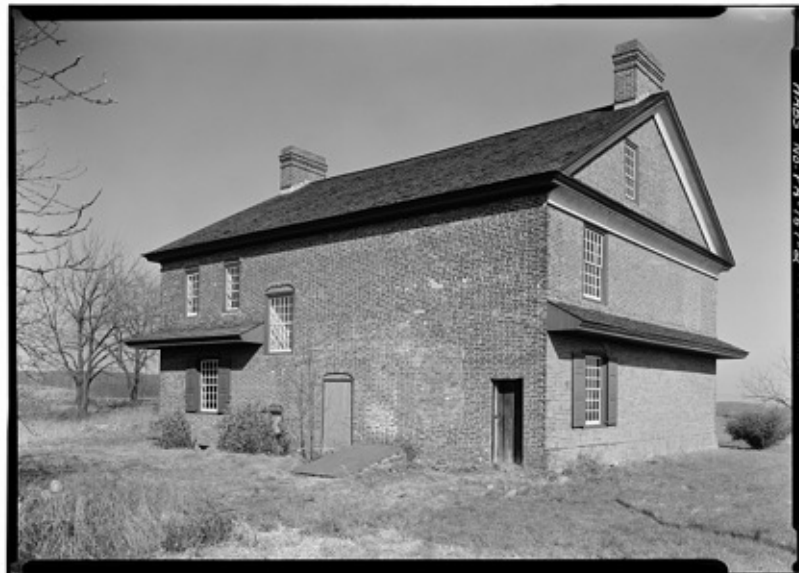
1959 HABS Photograph, North Elevation. Core restoration complete except for door removal and north kitchen reconstruction.

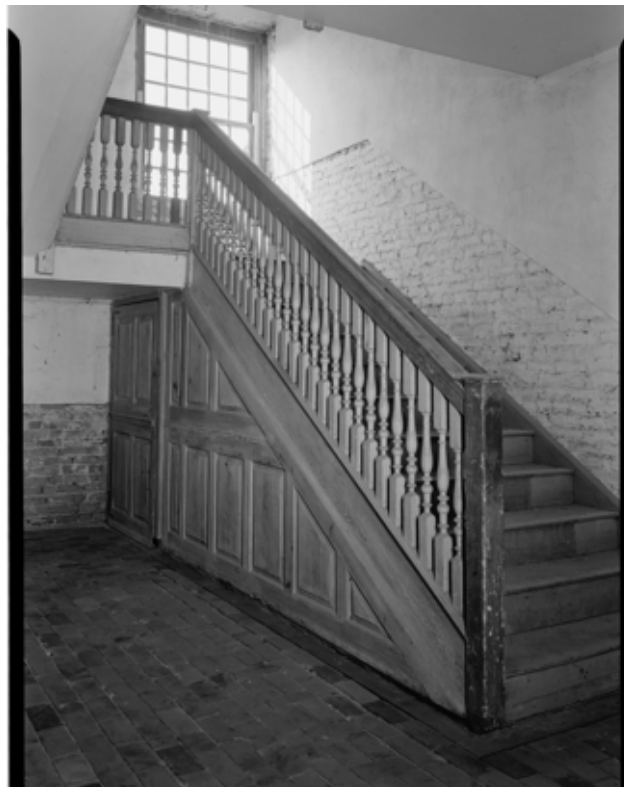
1959 HABS Photo. Of Hall Stairway. A number of the restoration needs are shown. Missing wainscoting requires replacement and paint requires removal on stairway banister. The brick hallway floor has been laid.

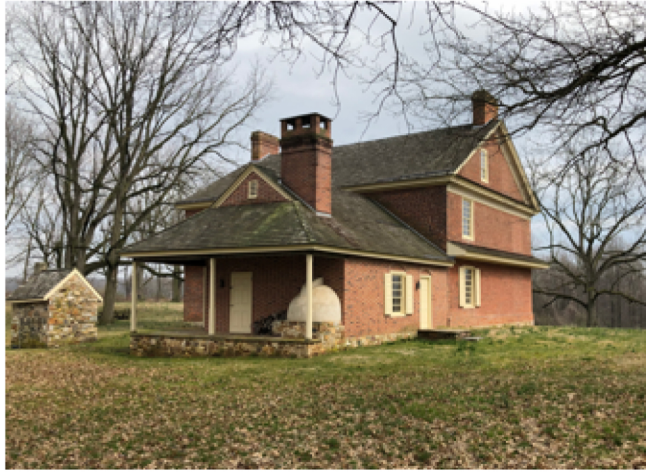
The Kitchen was designed by Raymond Sipe, Architect.

In 1999 the Primitive Hall Foundation Board moved forward to establish a kitchen at the north west corner of Primitive Hall building. In practice the writer finds the current location of the reconstructed kitchen works well for telling the story of life at the Hall in 1738 and as well as a support facility for programs at the Hall. Visitors can view the historic

core and then move easily to the kitchen. The location also preserves unimpeded front views of the historic core.
